Petersburg Medical Center

Seismic Evaluation Report

July 2019

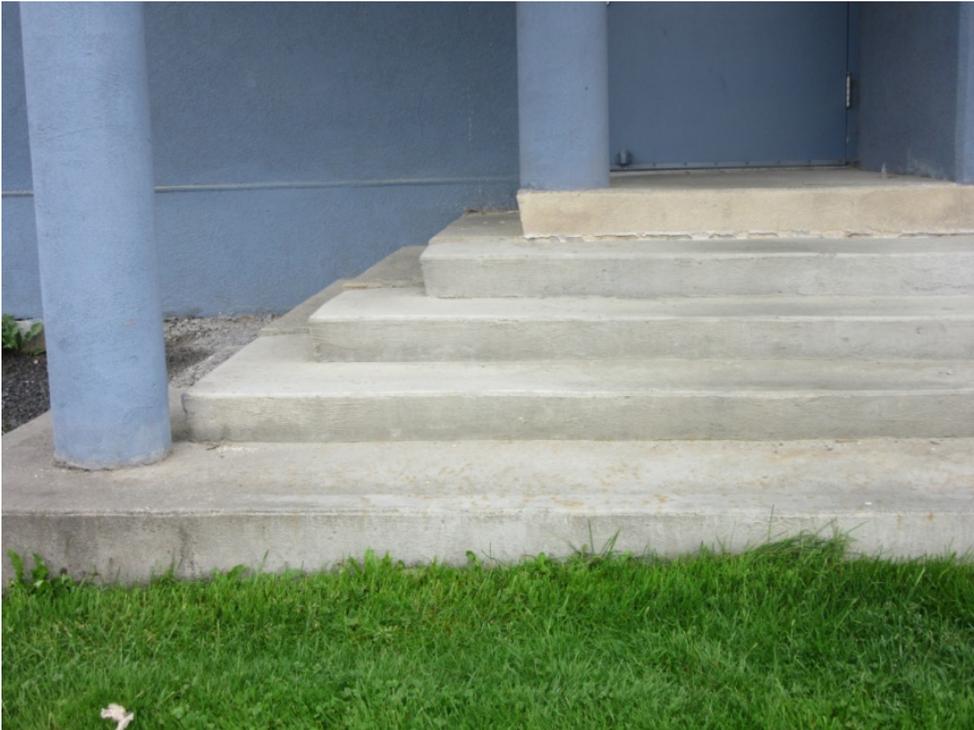
Figure 2-4: Settlement at Long Term Care Wing Exterior Stair

Minor settlement of the exterior stair on the west side of the building relative to the building was noted at the Long Term Care Wing. See Figure 2-4. If these concrete stairs are supported on spread footings, whereas the building is pile supported, that could account for the settlement.

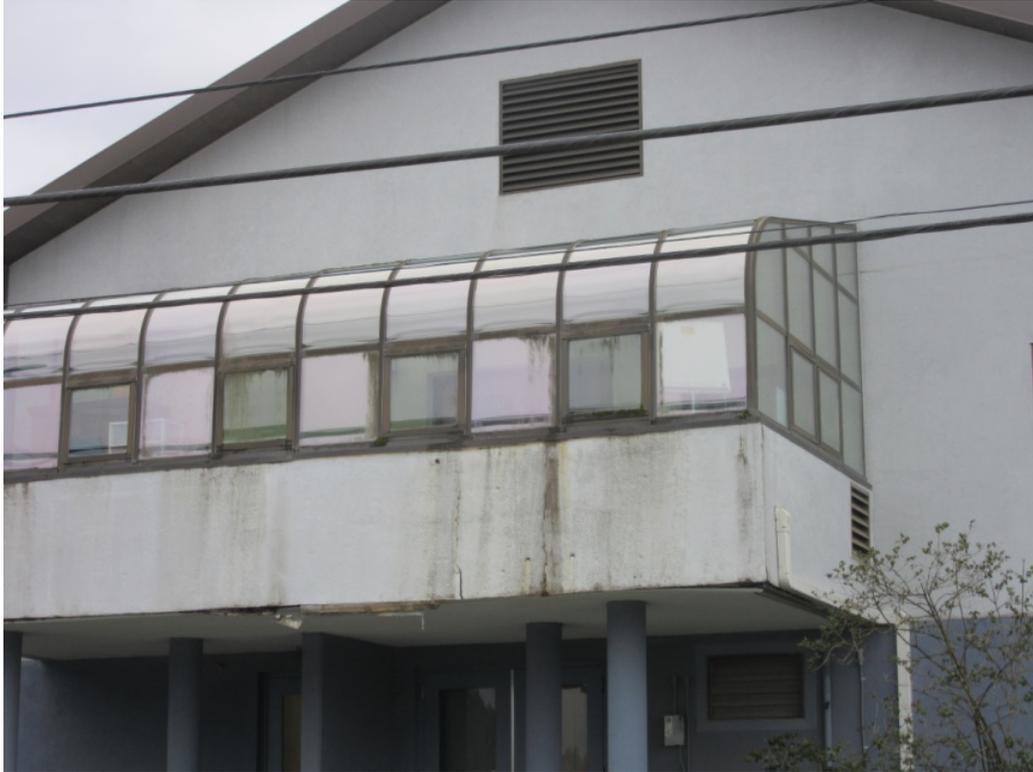
Figure 2-5: Cladding Damage at Long Term Care Wing Exterior Sun Room

The cladding at the sun room at the west side of the Long Term Care Wing is damaged, likely due to weather and water penetration issues. See Figure 2-5. There is no apparent damage to the building structure in this area.

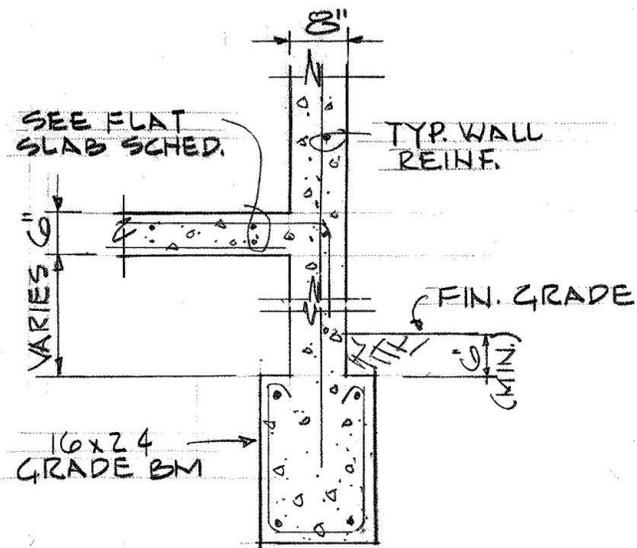
Figure A1: Long Term Care Wing – Foundation Dowels (Section F/S-3)

- **Building Type C2 - Foundation Dowels:** Concrete shear wall vertical reinforcement dowel embedment lengths into the foundations are less than that required to develop the strength of the walls. For reference, see Section F/S-3 shown in Appendix A, Figure A1.
- **Building Type C2 - Deep Foundations/Connections:** Cedar pile tension capacities unknown. No tension connection between piles and pile caps to resist uplift. No top reinforcement in pile caps. For reference, see Section 1E/S-2 shown in Appendix A, Figure A2.
- **Building Type S4 – Connections:** Attic horizontal bracing system has insufficient capacity to transfer lateral forces to concrete shear walls.

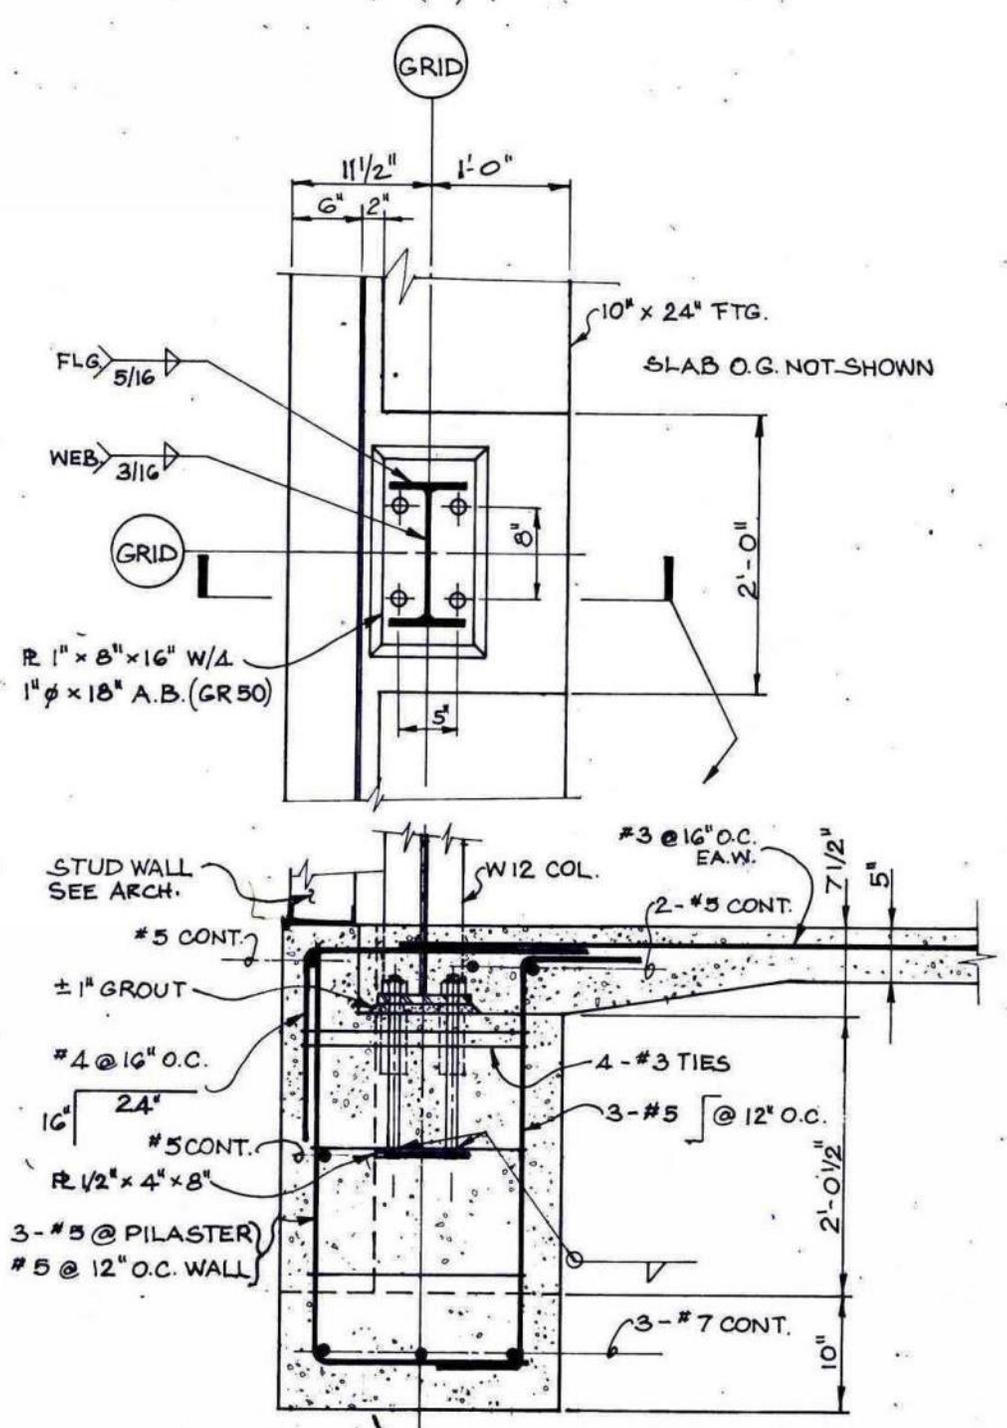
Figure A3: Hospital – Steel Columns (Section 4/S-7)

- **Building Type S1 – Steel Columns:** Connections of moment frame columns to foundations insufficient to develop tensile capacity of columns. For reference, see Section 4/S-7 shown in Appendix A, Figure A3.

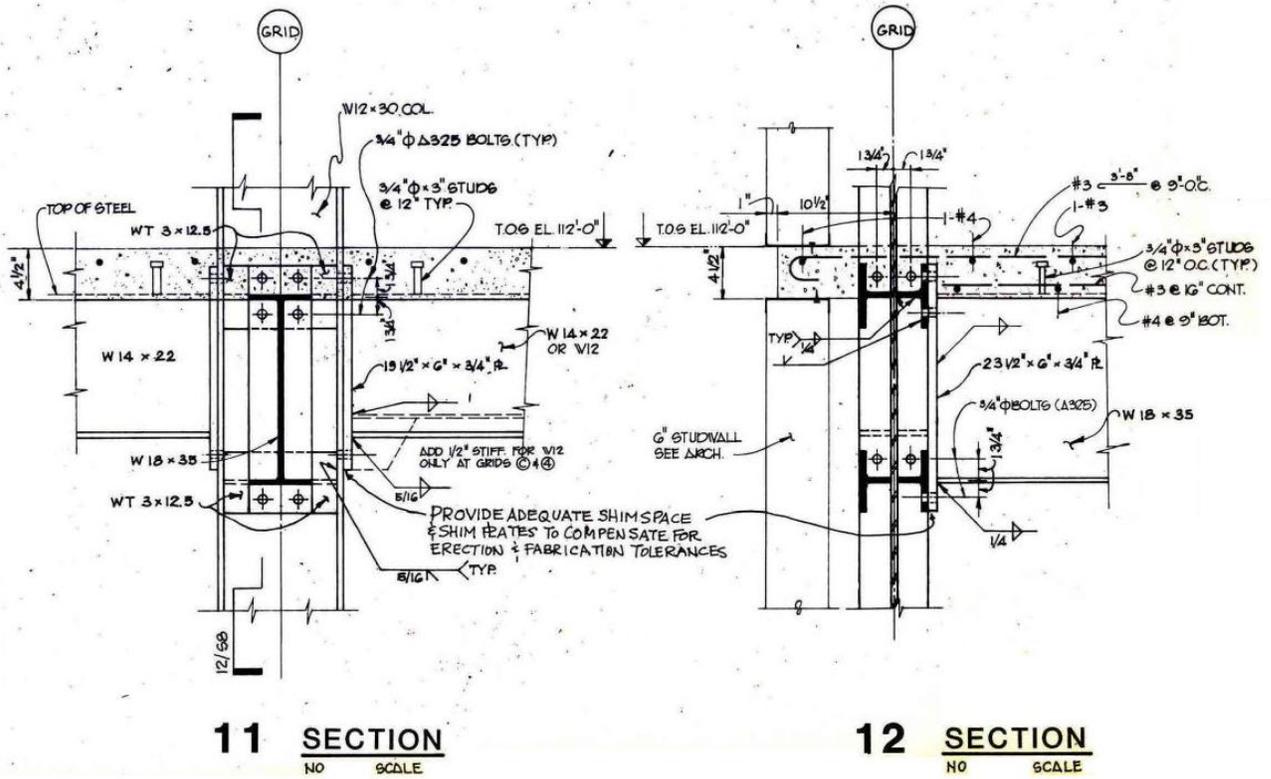
Figure A4: Hospital – Moment-Resisting Connections/Girder Flange Continuity Plates (Section 11/S-8 and 12/S-8)

- **Building Type S1 – Moment-Resisting Connections:** Based on information provided on the drawings, it cannot be verified and is considered unlikely that moment frame connections are able to develop the strength of the beams. For reference, see Sections 11/S-8 and 12/S-8 shown in Appendix A, Figure A4.

- **Building Type S1: Compact Members:** Moment frame members do not meet compact section requirements.
- **Building Type S1: Girder Flange Continuity Plates:** There are no girder flange continuity plates at the moment frame joints. For reference, see Sections 11/S-8 and 12/S-8 shown in Appendix A, Figure A4.
